## FATAL FACTS

ELEVATOR INDUSTRY WORK PRESERVATION FUND

### Fatal Facts

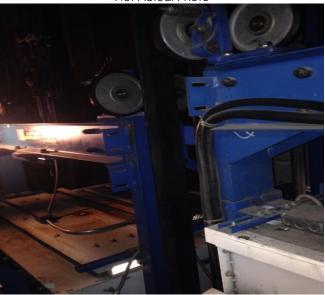
A mechanic was oiling cables on top of the elevator, when he fell and was caught between elevators. He died from his injuries.

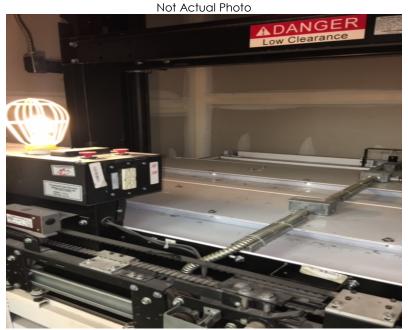
An elevator mechanic was working on electrical boxes on the top of a hydraulic passenger elevator. The elevator was not grounded. An insulation breakdown or failure in the ballast of the elevator's florescent lighting fixture energized the entire elevator car. (The ballast was in metal-to-metal contact with the ceiling of the car.) The mechanic was electrocuted.

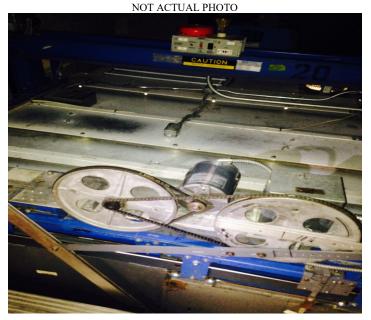
A helper, and an elevator mechanic, completed servicing an Elevator and were returning it to service. The elevator mechanic exited the elevator and the helper followed. The helper switched the car operating device from inspection to run. Jumpers that had been used to bypass the hoist way door interlock had not been removed and the elevator immediately began to ascend. The helper was caught between the elevator and hoist way as the elevator ascended and was killed.
