IUEC INCIDENT SUMMARY

AUGUST 7, 2024 | INJURY

IUEC Safety Stand Down Day | April 28, 2025

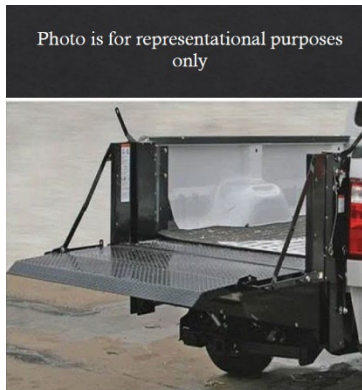
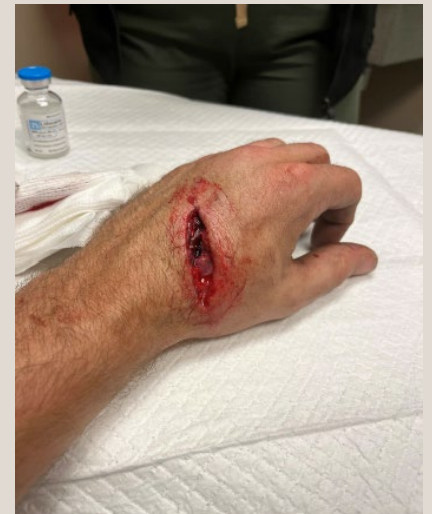
Two repair crews were unloading a generator from the back of a truck equipped with a liftgate. The generator was on a four-wheel dolly to move the generator into the building. As the crews pushed and pulled the dolly/generator onto the liftgate they lost control of the load. One of the apprentices tried to stop the load from falling off the truck, suffering bruises, abrasions, and a severe laceration to his left hand.

Current Status: The apprentice required surgery to repair tendons in his hand. He will miss at least 2 to 3 months of work while he recovers.

Using an undersized vehicle and/or platform to move equipment.
No standard work practice to secure loads to moveable platforms.

Always follow the company safety policy.
Always perform a JHA/JSA as per company policy.
Never attempt to catch or stop a load you cannot lift by yourself.

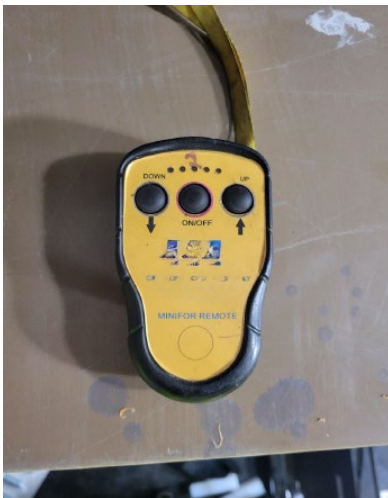
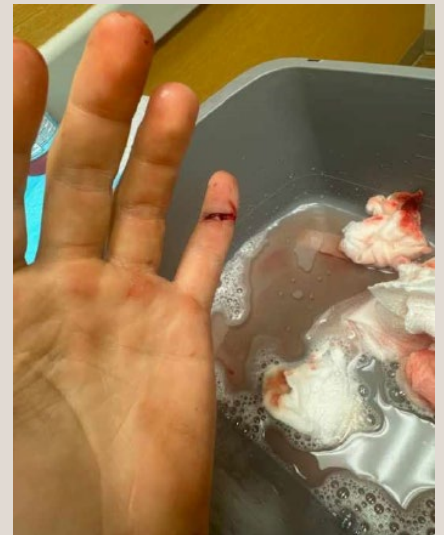
Once communications were reestablished, the apprentice began to hoist the platform. The load shifted and swung into the apprentice, crushing his pinky finger between a 2x4 mounted on the wall and the platform.

Current Status: The apprentice had surgery to repair the broken finger and will remain on light duty for 6 to 8 weeks.

- Unstable wireless communications.
- Not positioned properly in the event of load shift.
- Not using a reliable wired control device.

- Always follow the company safety policy.
- Always perform a JHA/JSA as per company policy.
- Always stay clear of the load when hoisting.
