IUEC INCIDENT SUMMARY

AUGUST 30, 2024 | CLOSE CALL

SEPTEMBER 3, 2024 | INJURY

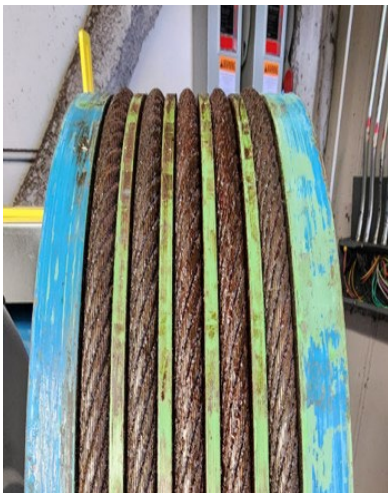
The apprentice ran the car in the down direction. When he released the enable and down buttons, the car continued in the down direction 10-12 feet until it crashed onto the buffers.

The inspector had the crew perform an emergency stop test and the car again crashed onto the buffers.

Brake pads worn down to the rivets.

Hoist ropes in use beyond replacement criteria.

Over lubrication of hoist ropes reducing traction.

Current Status: The braking system was repaired, and the hoist ropes were replaced before the elevator was returned to service.

Brakes shall be maintained and tested per ASME A17.1/CSA B44 (see 8.6.4.6 and 8.10.2.2.2(v))

Steel wire ropes shall be maintained per ASME A17.1/CSA B44 (see 8.6.4.1). Precautions shall be taken in lubricating suspension steel wire ropes to prevent the loss of traction.

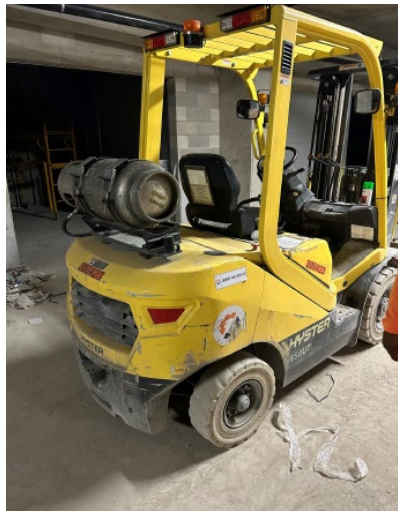
The mechanic operating the forklift did not see the other mechanic approach and when he turned the forklift, the rear tire ran over his foot.

Not establishing proper communication protocols

Photograph is for representational purposes only

- Always follow the company safety policy.
- Always perform a JHA/JSA as per company policy.
- Never approach a vehicle from behind when it is in operation.
