# IUEC INCIDENT SUMMARY

IUEC Safety Stand Down Day | April 28, 2025

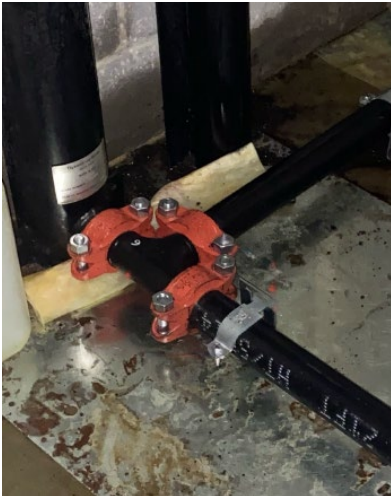
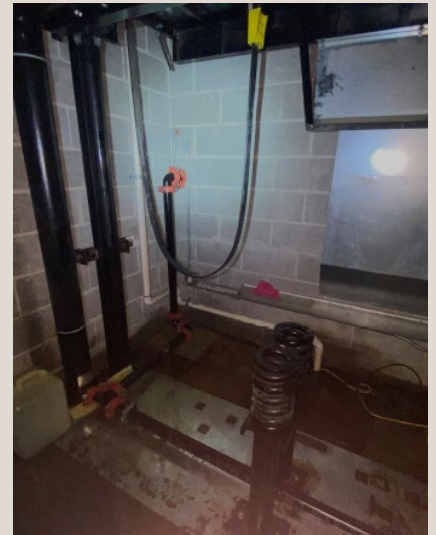
When the car was run onto the stop ring to verify the 480 PSI relief setting, the system reached a pressure of 440 PSI before the pressure dropped and the car descended uncontrollably onto the buffer springs.

After the elevator was hoisted and placed on pipe stands a follow up inspection was performed. It was determined that a Victaulic seal had failed, and the likely cause was a loose Victaulic coupling.

Failure to inspect the hydraulic system for leaks or loose connections prior to performing a Category 1 test.

**Current Status:** The elevator pit was cleaned, all necessary repairs were made, and the hydraulic system was tested.

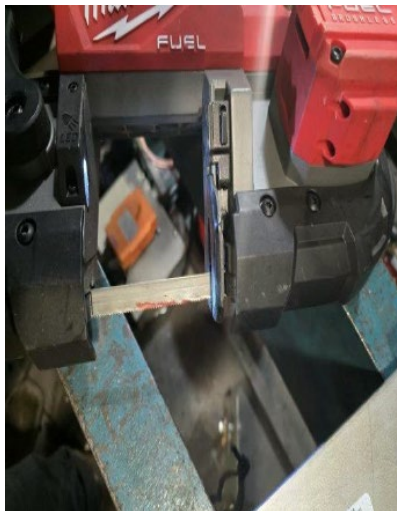
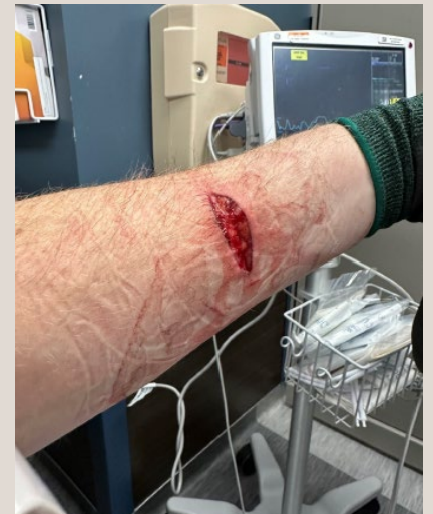
An apprentice was cutting a bracket while on the car top during a modernization.

The apprentice clamped one side of the bracket to the crosshead and held the other side with his left hand. Using one hand to operate the saw, as the cut was completed, he lost control, and the saw landed on his left arm causing a deep laceration.

Cutting material in a location that does not allow for adequate set up or body position.  
Failure to properly secure materials prior to cutting.  
Not using two hands while operating power cutting tools.

Always follow the company safety policy.  
Always perform a JHA/JSA as per company policy.  
Consider using dual-trigger band saws which require two hand operation.

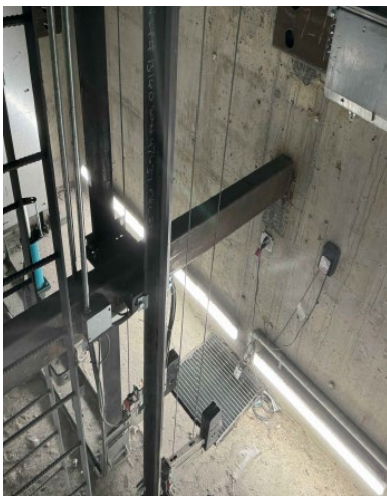
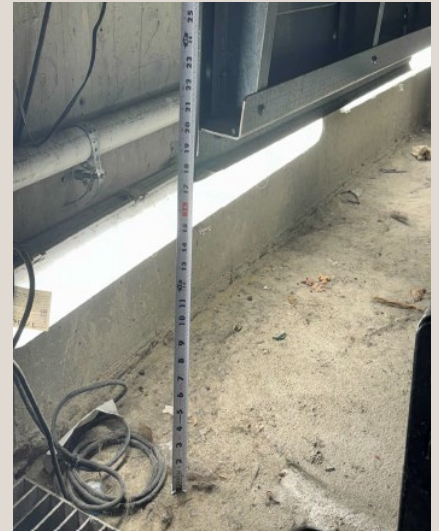
Two maintenance mechanics were installing hold down brackets for filler weights when a piece of hardware fell into the sump well of a duplex pit.

One of the mechanics tried to remove the metal grating from the well when the coupling for the sump pump discharge line failed and water began spraying onto the mechanic.

The mechanic repositioned himself to reach for the hardware and was struck by the rear entrance toe guard of the adjacent car, knocking him down and pinning him to the pit floor.

The sump well cover was not properly installed requiring disassembly of the discharge line for removal.  
Failure to control both elevators when accessing a shared space.

Always follow the company safety policy.  
Always perform a JHA/JSA as per company policy.  
Separation of Adjacent Pits.
