IUEC INCIDENT SUMMARY

FEBRUARY 2, 2024 | INJURY

MAY 7, 2024 | CLOSE CALL

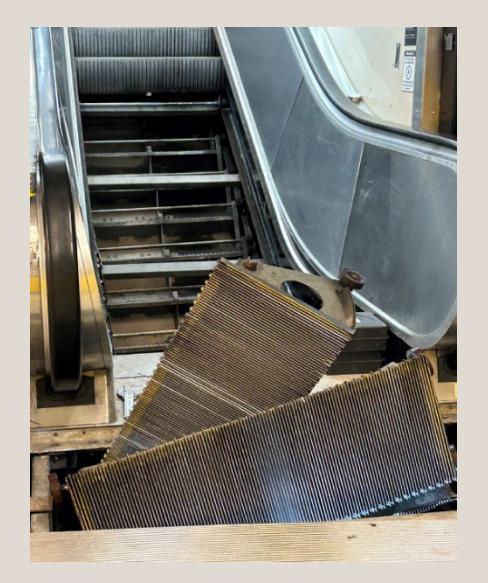
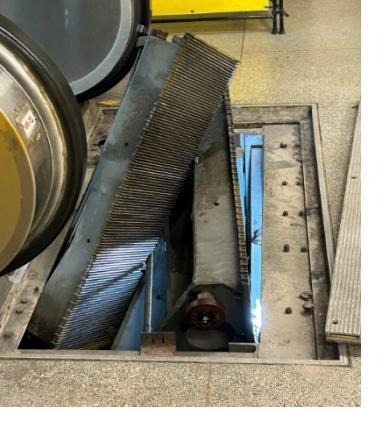
A mechanic was in the lower well of an escalator removing steps. The unit was not equipped with a pendant for inspection operation.

While the mechanic was removing the first step it didn't line up with the crab track, so he pushed the step back in and attempted to jog the unit to have it line up.

When he jogged the unit, the escalator started to run on automatic and the steps began to pile up while he was still in the well.

Lack of a pendant station for inspection operation. Lack of Standard Work Practice for step removal.

Always follow the company safety policy. Always perform a JHA/JSA as per company policy. Always follow the MCP. Never stand in the truss or pit while moving an escalator.

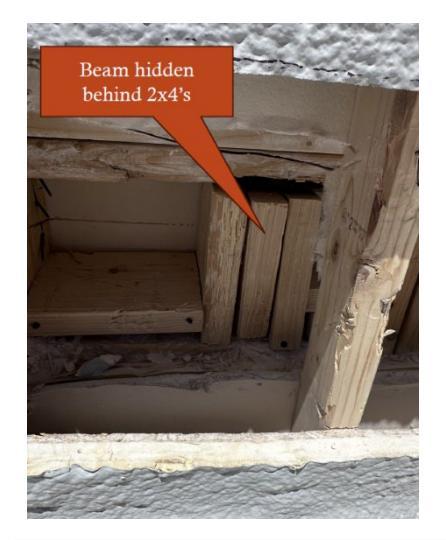
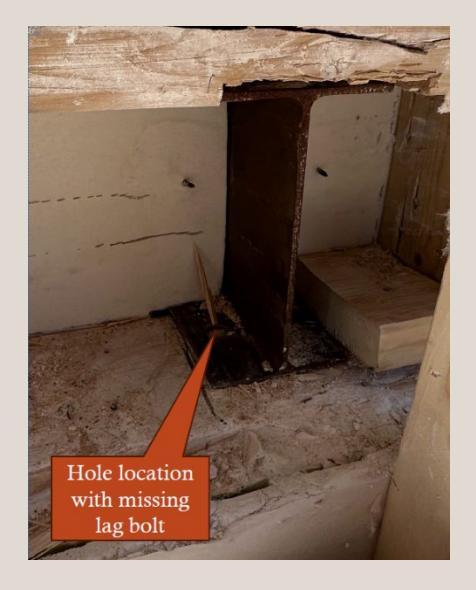
An extension ladder was placed from the top landing to the back wall of the hoistway. The apprentice climbed the ladder, grabbed the hoisting beam, shook it and noticed it was not solidly attached.

The beam attachment was enclosed by drywall on the hoistway side and stucco covered the outside of the hoistway. The crew notified their superintendent and the General Contractor.

The GC directed the framing crew who installed the beam to open the exterior wall to expose the beam. The beam had 2x4's wedged in place to prevent the beam from flipping. No lag bolts were installed as required by the engineered drawings.

The framing crew confirmed their foreman directed them to use the 2x4's because they did not have the required lag bolts.

No verification process of proper installation of hoisting beams.

Current Status: The beam was secured properly using 5/8" lag bolts as required. The other two hoistways on-site were inspected and found to be missing the 5/8" lag bolts. The problem was corrected on all hoistways.

Always follow the company safety policy. Always perform a JHA/JSA as per company policy. Always verify anchorages for lifelines. Hoisting and rigging must be properly secured.

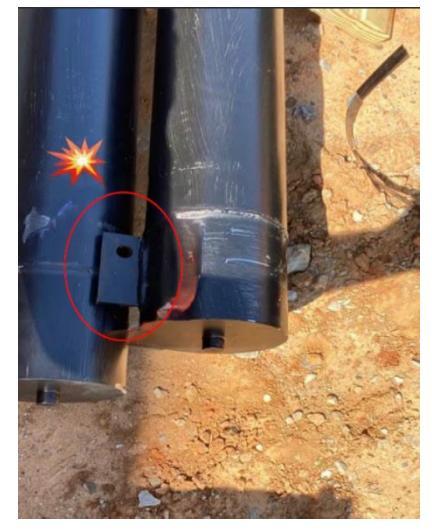
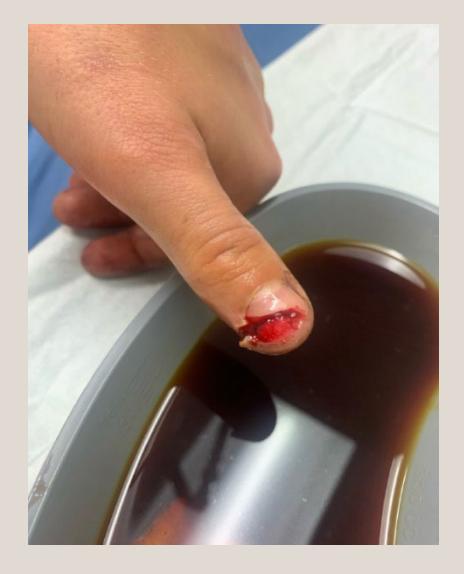
Two hole-less hydraulic jacks and rails were bundled together on the same pallet when they were delivered to the jobsite.

While moving the second jack, the load slipped off the pallet, smashing his thumb between the two jacks, causing a deep cut through his thumb and nail bed.

Lack of awareness. Lack of experience unloading mixed materials.

Always follow the company safety policy. Always perform a JHA/JSA as per company policy. Always ask for assistance when lifting heavy or awkward loads.
