IUEC INCIDENT SUMMARY

CLOSE CALLS, NEAR MISSES AND INJURIES
STRUCK BY INJURY

“INJURY”

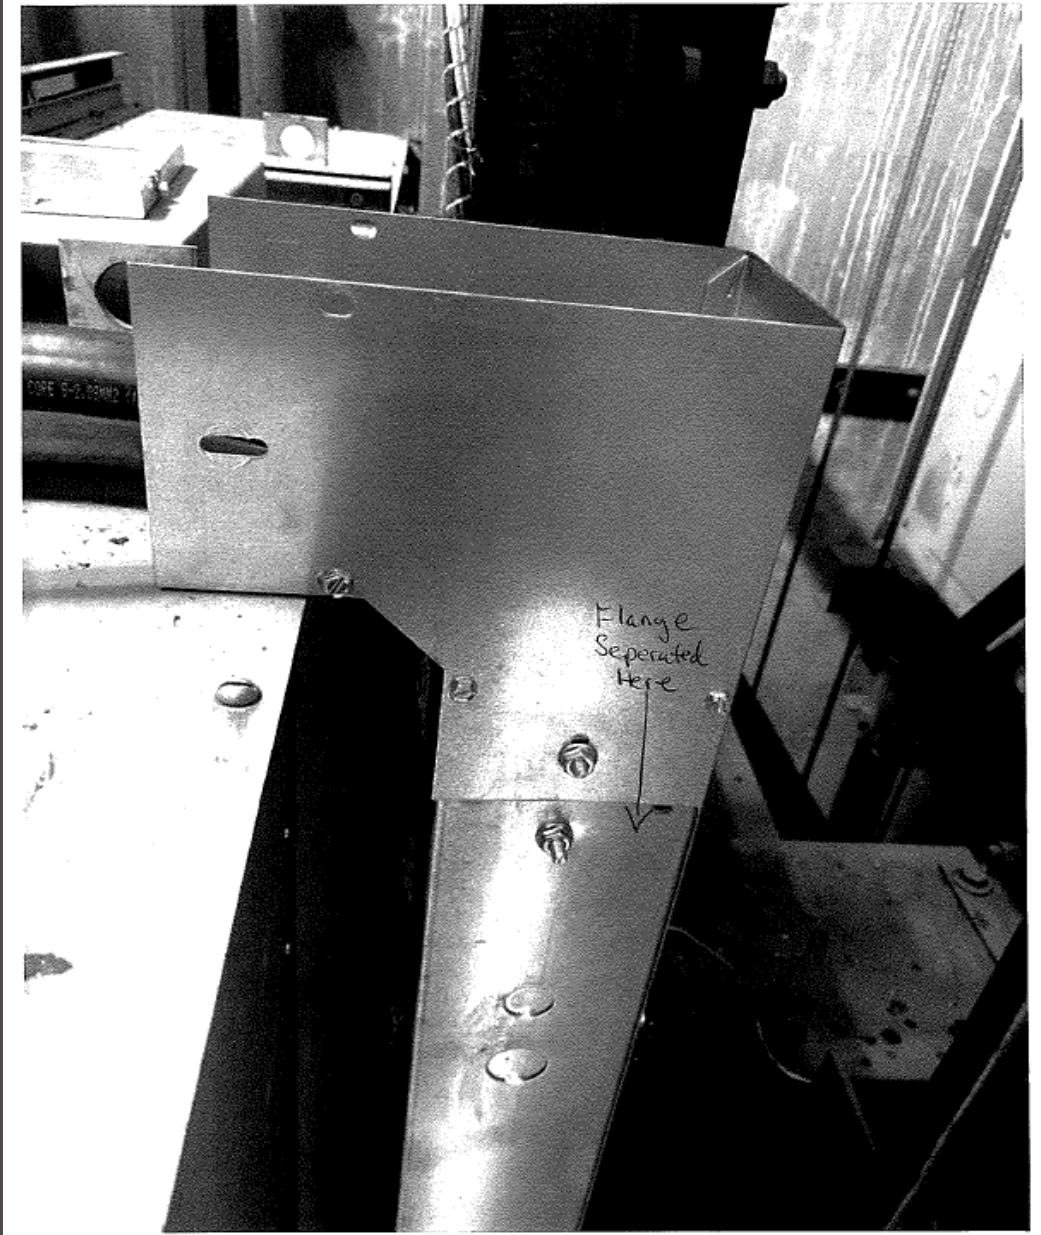
- A mechanic and an apprentice were hanging 4X4 duct on the side of the car for the traveler to pass through to the car top box.
- The manufacturer of the duct work is Draka.
- During the installation of the duct work, the spot welds broke which caused the duct to shift and fall while the Apprentice was holding it in place.
- When the duct fell it caused severe wrist lacerations down to the bone, severed tendons, veins and arteries, and fractured his wrist. The apprentice is currently recovering from surgery.
- The picture on the left shows the repairs to the duct work.
- As you can see, the repairs made on the job show that the duct is now drilled and through bolted to eliminate or reinforce the spot welds.

- Always follow the company Safety Policy.
- Always perform a JHA/JSA per company policy.
- Inspect all spot welds and if necessary, drill and through bolt them to hold the sections together.
- The General Duty Clause of the OSH ACT of 1970 is Section 5(a)(1) requirements:
 - Each employer shall furnish to each of his/her employees' employment and a place of employment which are free of hazards that are causing or are likely to cause death or serious physical harm to his/her employees'.
