## IUEC INCIDENT REPORTS

CLOSE CALLS , NEAR MISSES AND INJURIES

"INJURY"

## Incident Report

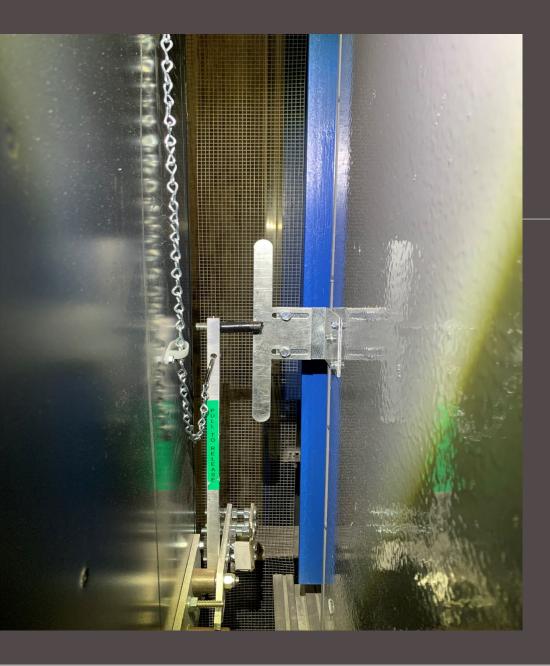
- The mechanic was working from a ladder and the apprentice was kneeling on the car top, leaning over, handing tools and hardware down to the mechanic.
- The mechanic completed the task and handed the apprentice the tools to place back on the car top.
- When the mechanic was off the ladder and clear, the apprentice ran the car down to pick up the mechanic. The mechanic noticed the apprentice had something dripping down his leg.
- The apprentice looked at his knee and saw a hole in his pants. The apprentice lifted his pant leg and saw he had a laceration to his knee.
- The apprentice remembers bumping his knee on the door restrictor flag and that is where he believes he received the laceration.
- The apprentice received six stitches to his knee.

- Always follow company safety policies
- Always perform a JHA/JSA according to company safety policy
- Sharp edges on door restrictor flags mounted to hoistway doors must be de-burred.
- Be aware of your footing and walking/working surfaces while performing tasks.
  - Employer Responsibilities
  - The OSH Act of 1970 Section 5, requirements
- \*Each employer shall furnish to each of his/her employee's employment and a place of employment which are free from recognized hazards that are that are causing or are likely to cause death or serious physical harm to his/her employee's.
