IUEC INCIDENT SUMMARY

APRIL 11, 2024 | INJURY

Description of Incident

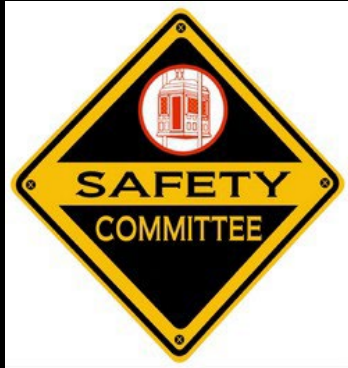
A mechanic was replacing a car door reopening device on an elevator that did not have hoistway access.

After removing his lockout and tagout, he returned to the car top and placed the car on automatic operation to allow the elevator to level into the floor so he could verify operation of the car door reopening device.

The doors opened but would not close. The mechanic placed the top-of-car inspection station back to inspection operation, but the car would not run, trapping the mechanic on the car top.

The mechanic opened the car top emergency exit and lowered himself into the elevator. As he passed through the escape hatch the sharp metal cartop cut his elbow.

Always follow the company safety policy.

Always perform a JHA/JSA as per company policy.

Always verify operation of top-of-car stop switches and inspections switches.

Top-of-car inspection operation was not verified.

Riding the car top on automatic operation.

Not using a ladder while using the car top emergency exit.

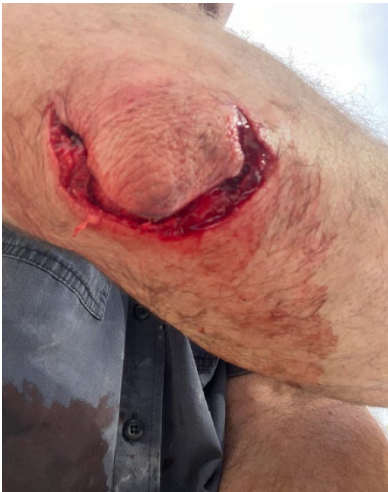
Photo is for representational purposes only

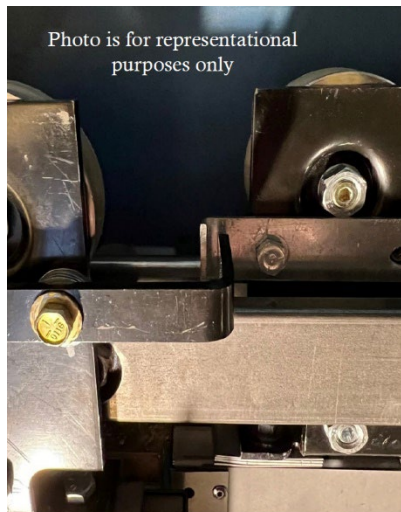
Warning – Contains Graphic Image

A crew was installing hanger roller brackets on a hall door at the lowest landing while the door was resting on the hoistway sill.

The door slipped off the sill and fell between the platform and hoistway door sill.

The hanger roller bracket hit the apprentice's hand and caused a severe laceration.

Always follow the company safety policy.

Always perform a JHA/JSA as per company policy.

Always follow SWPs.

Not securing stored energy.

Wearing gloves may have reduced the severity of the injury.

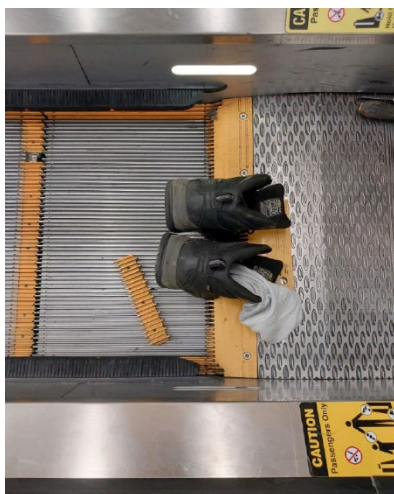
A crew removed a step to perform a missing step test at the top end of an escalator.

The hole was positioned a few steps in front of the combplate.

One mechanic was kneeling on the combplate with his back to the hole when he started the escalator.

As the escalator ran up his feet fell into the hole and became wedged between the step and the comb segments.

Always follow the company safety policy.

Always perform a JHA/JSA as per company policy.

Always follow SWPs.

Not following safe operating procedures.

Not facing the opening when the steps are removed.
