IUEC INCIDENT SUMMARY

AUGUST 30, 2024 | CLOSE CALL

SEPTEMBER 3, 2024 | INJURY

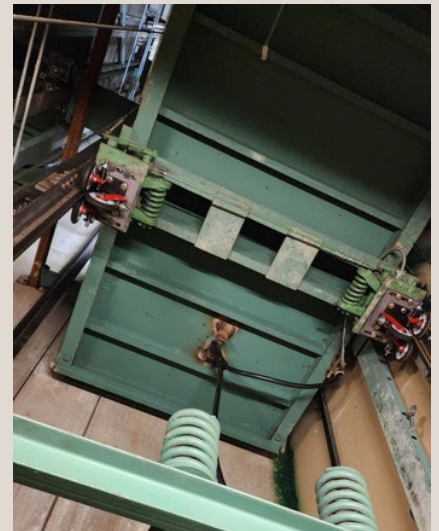
The apprentice ran the car in the down direction. When he released the enable and down buttons, the car continued in the down direction 10-12 feet until it crashed onto the buffers.

Brake pads worn down to the rivets.

Hoist ropes in use beyond replacement criteria.

Over lubrication of hoist ropes reducing traction.

Current Status: The braking system was repaired, and the hoist ropes were replaced before the elevator was returned to service.

Always inspect the condition & operation of components before performing tests.

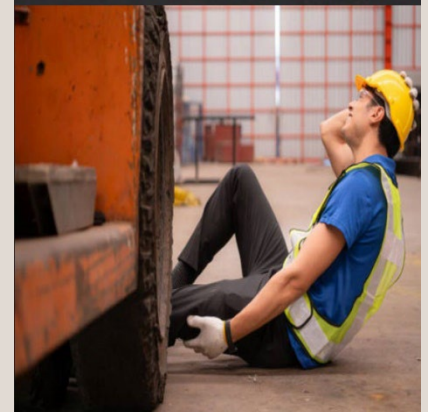
Photograph is for representational purposes only

The mechanic operating the forklift did not see the other mechanic approach and when he turned the forklift, the rear tire ran over his foot.

Not establishing proper communication protocols

- Always follow the company safety policy.
- Always perform a JHA/JSA as per company policy.
- Never approach a vehicle from behind when it is in operation.
